***Vapor Intrusion Evaluation
Activities Summary Report -
February to December 2016***

*Chemtura Site
3500 East 20th Street
Indianapolis, IN*

SCP #0000456

Prepared on Behalf of Chemtura Corporation

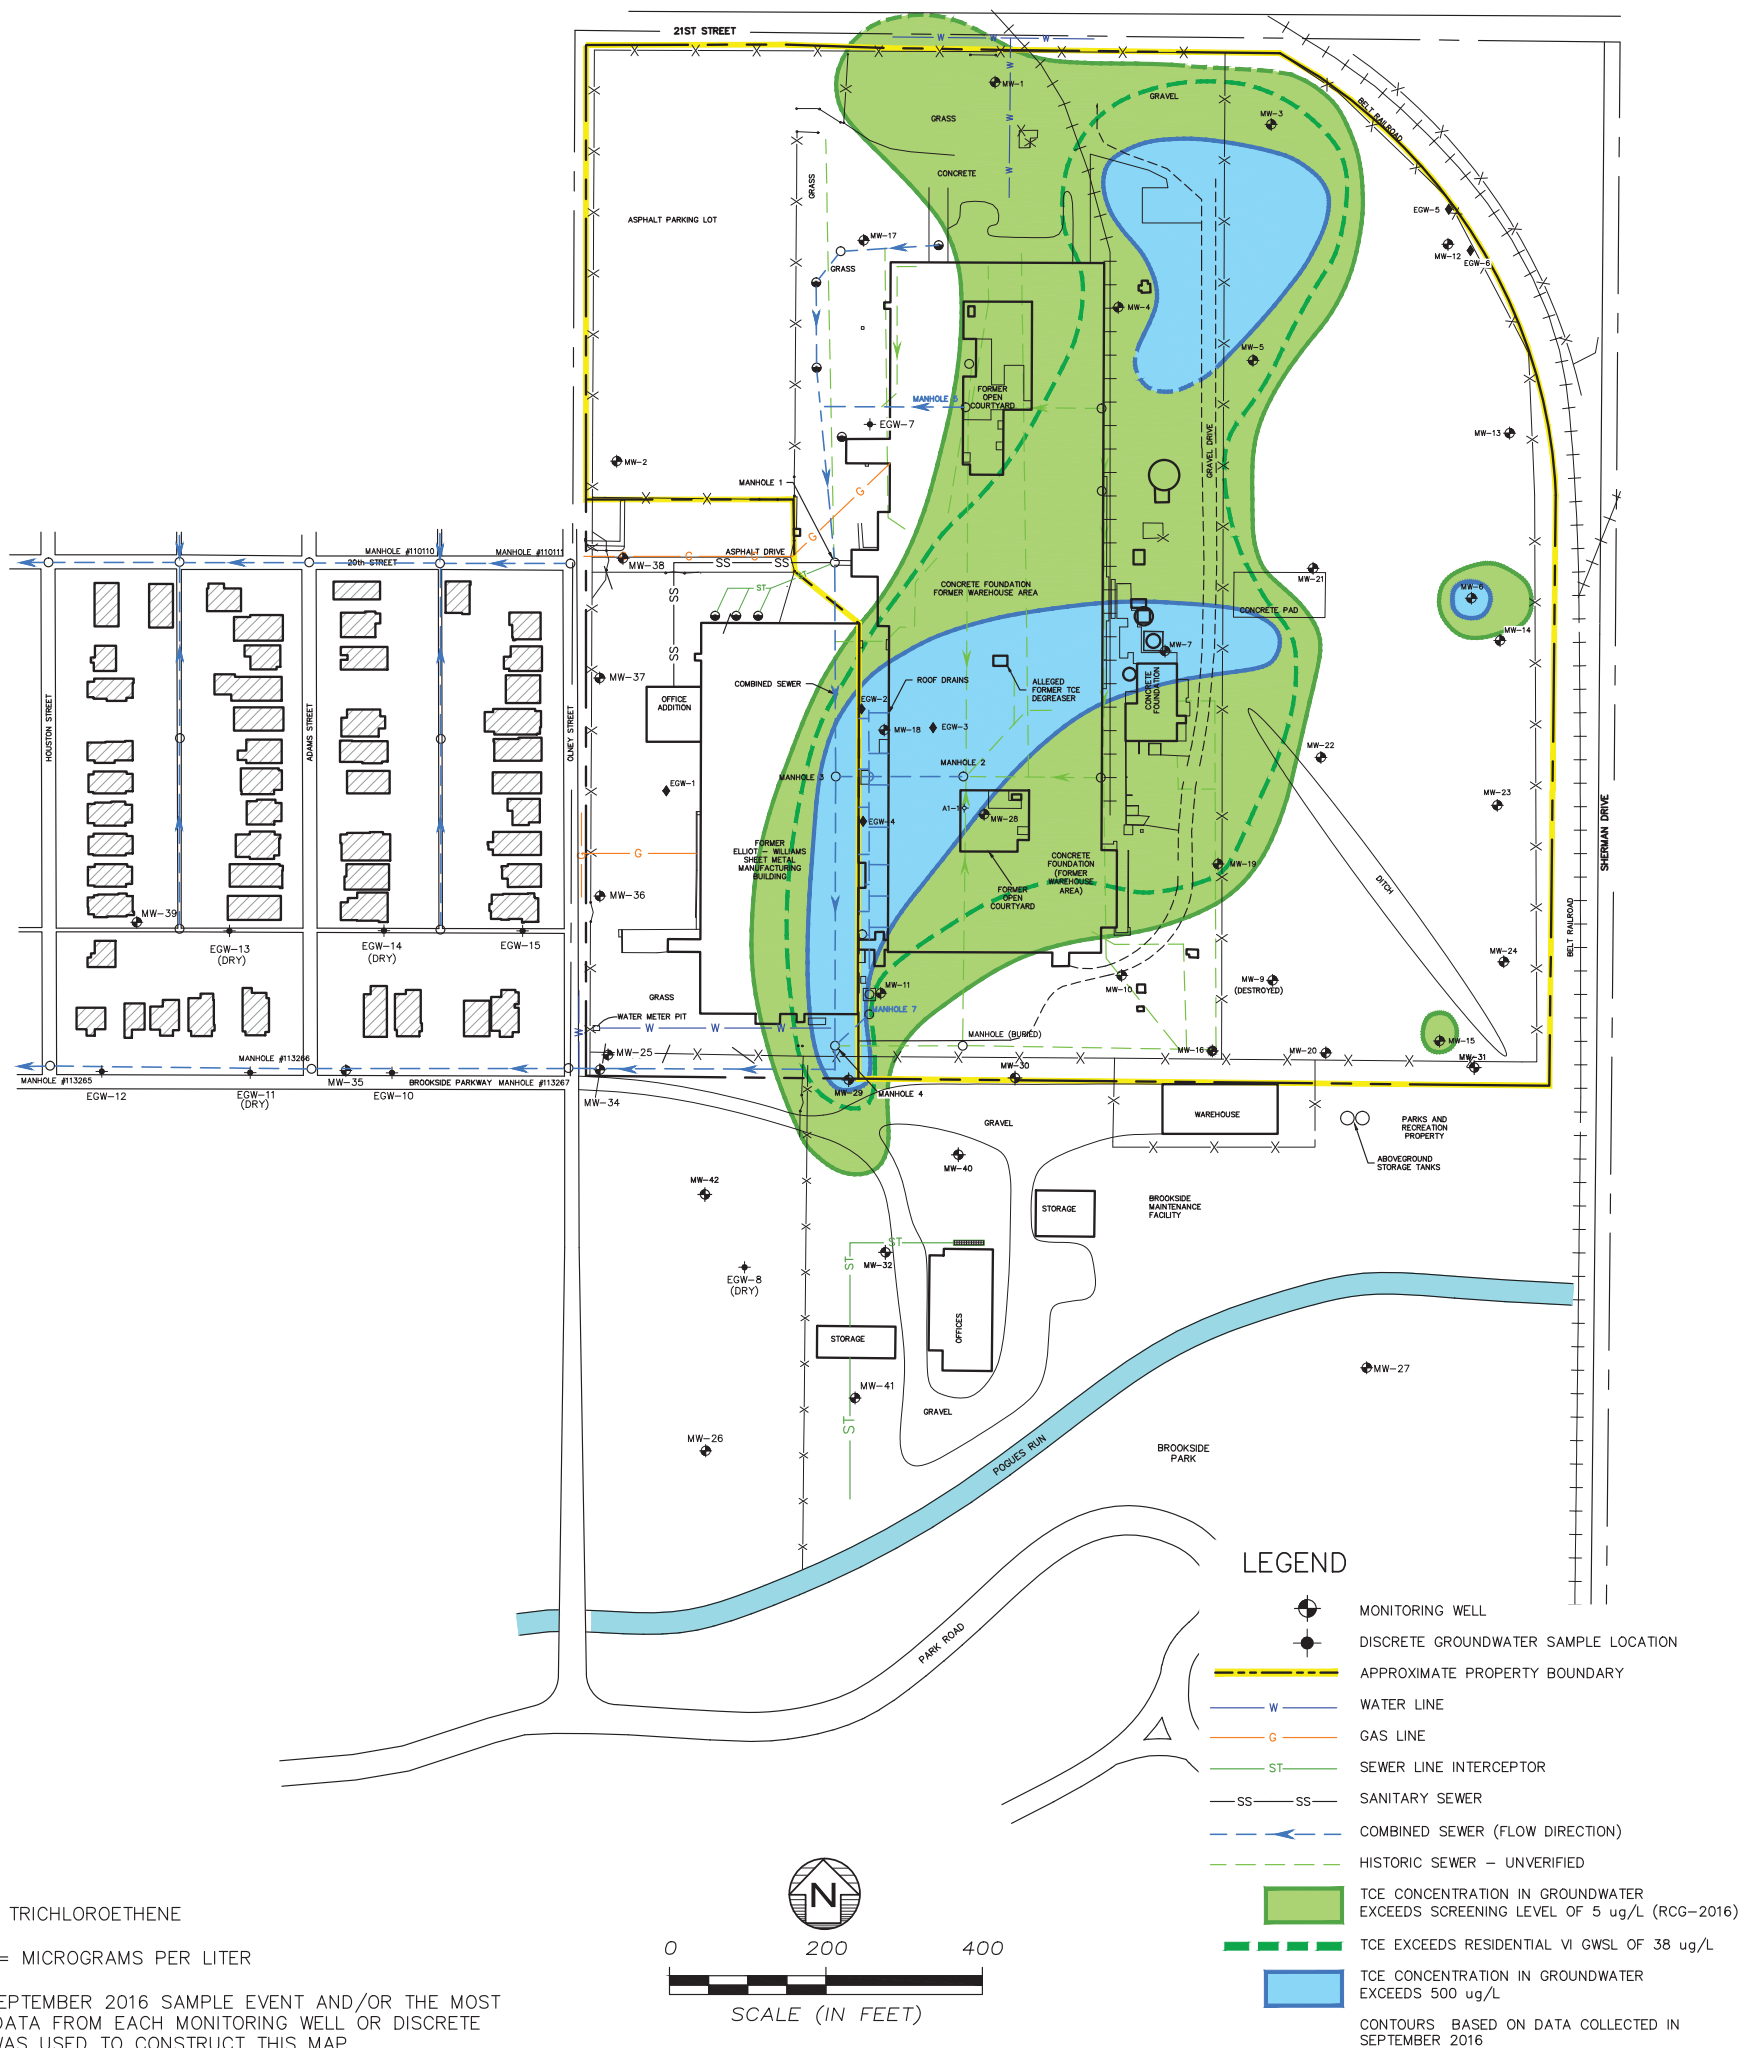
FIGURE 2

SITE MAP AND TCE IN GROUNDWATER ISOCONCENTRATION MAP

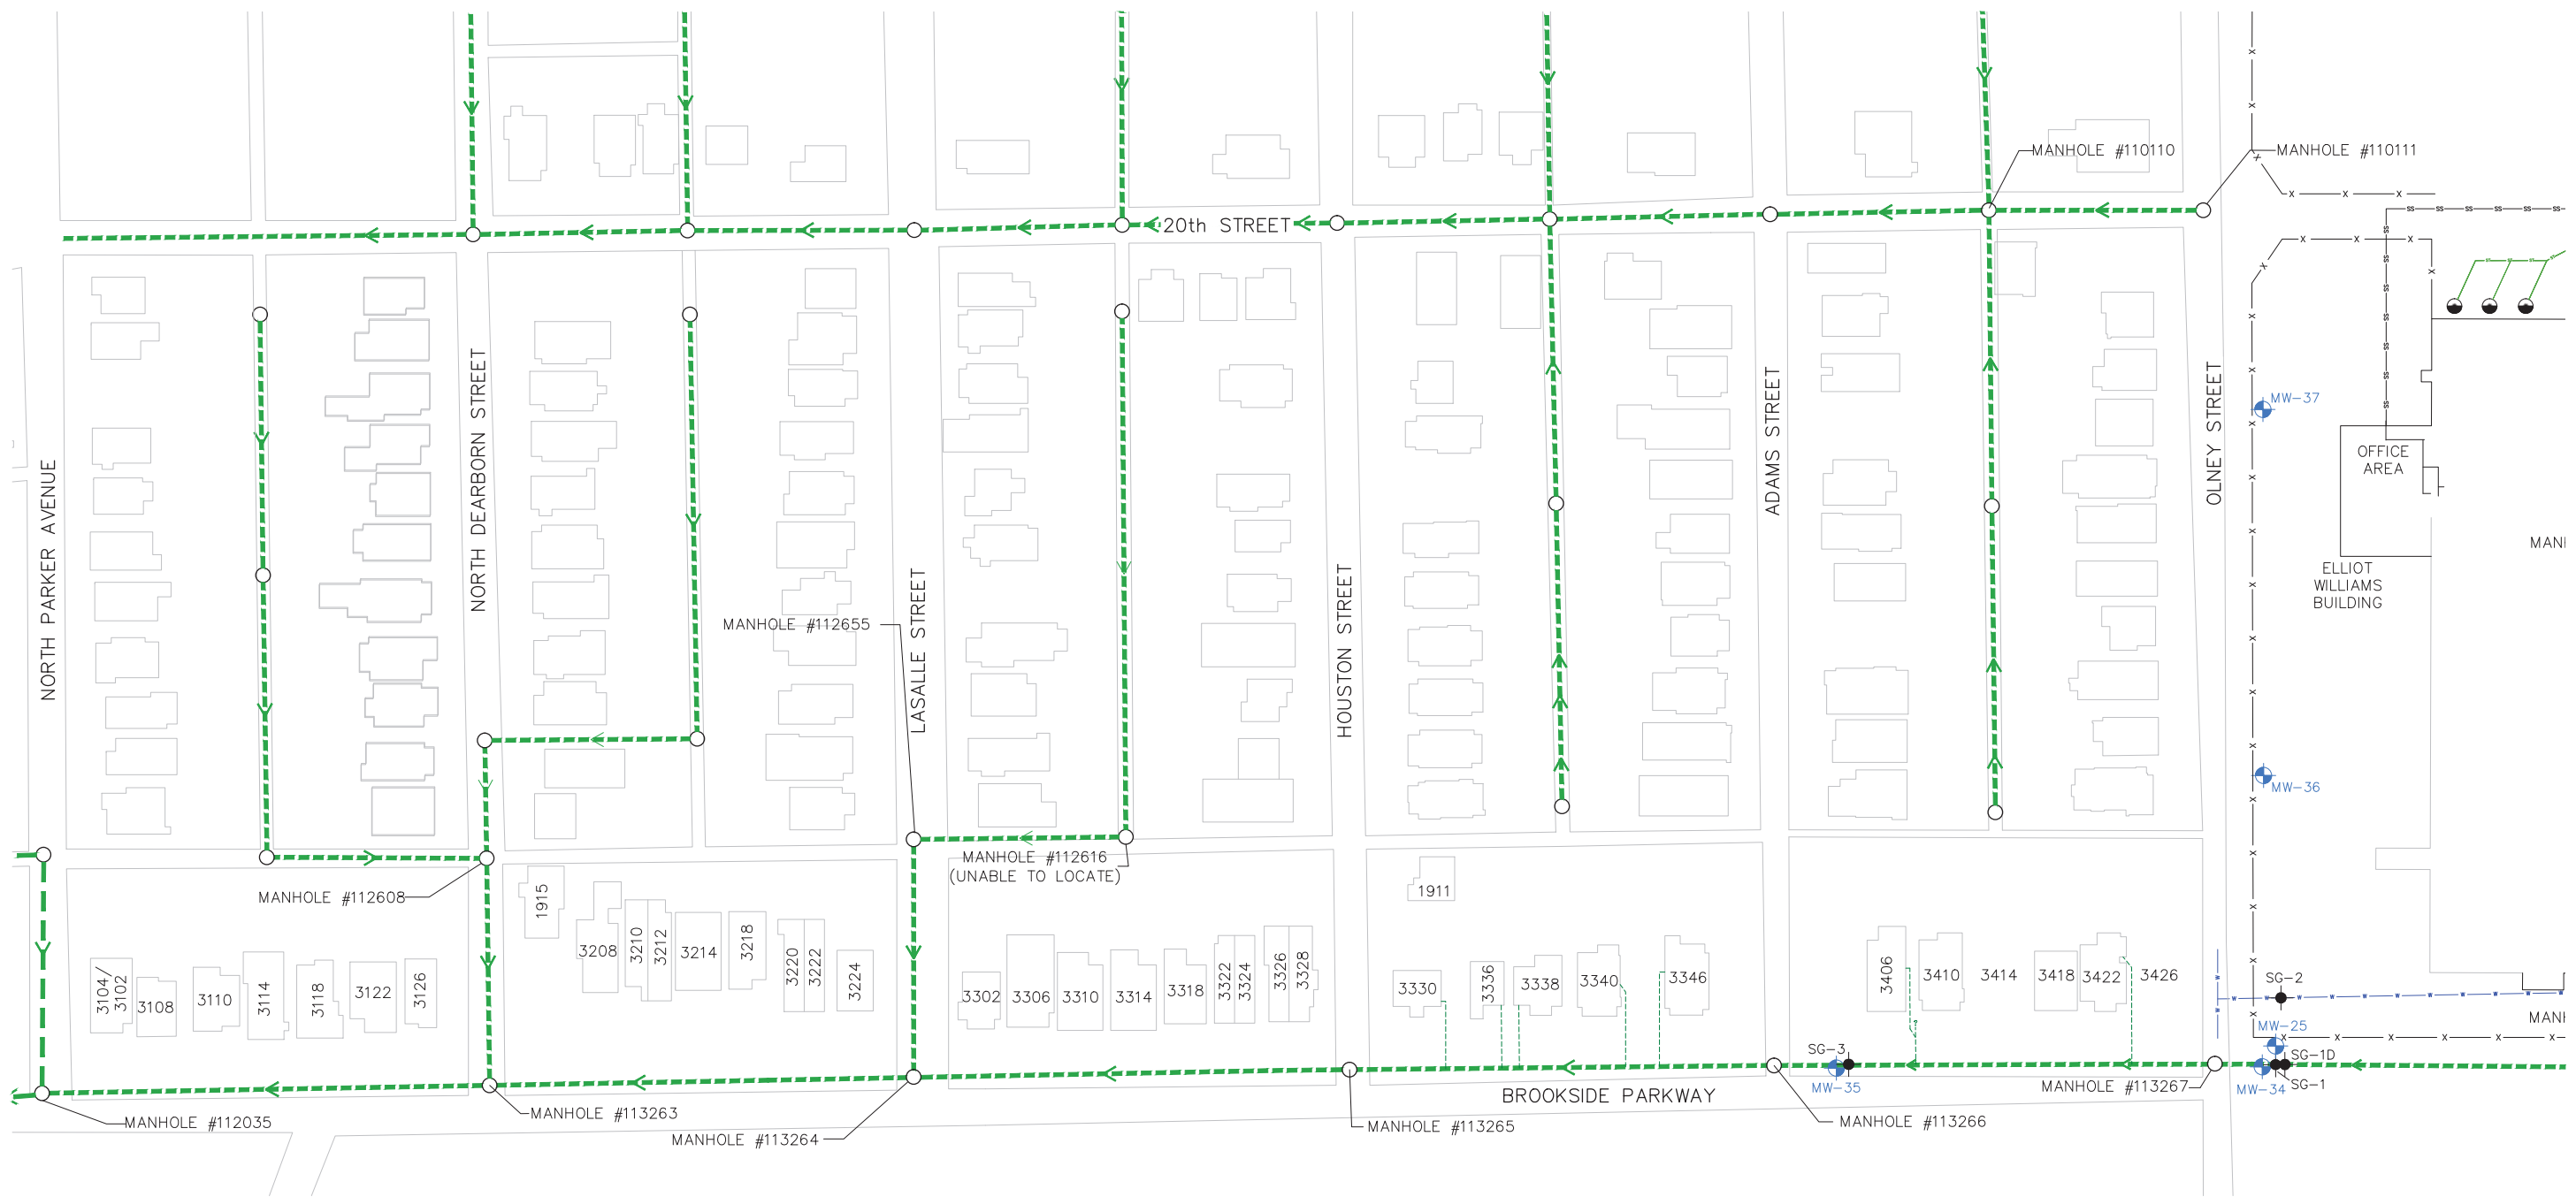
CHEMTURA SITE	
		3500 EAST 20TH STREET	
SCALE: AS NOTED	PROJECT NUMBER: 0330870	SHEET: FIGURE 3	REV.
DATE: 11/24/16

VAPOR INTRUSION SAMPLE LOCATIONS

These residences are shown on **Figure 3**. IDEM responded to the FOSVI Work Plan (August 19, 2016 comment letter) that additional residential VI evaluation sampling is required for certain residences not directly connected to the Sewer. These residences are noted below along with IDEM's corresponding reason:

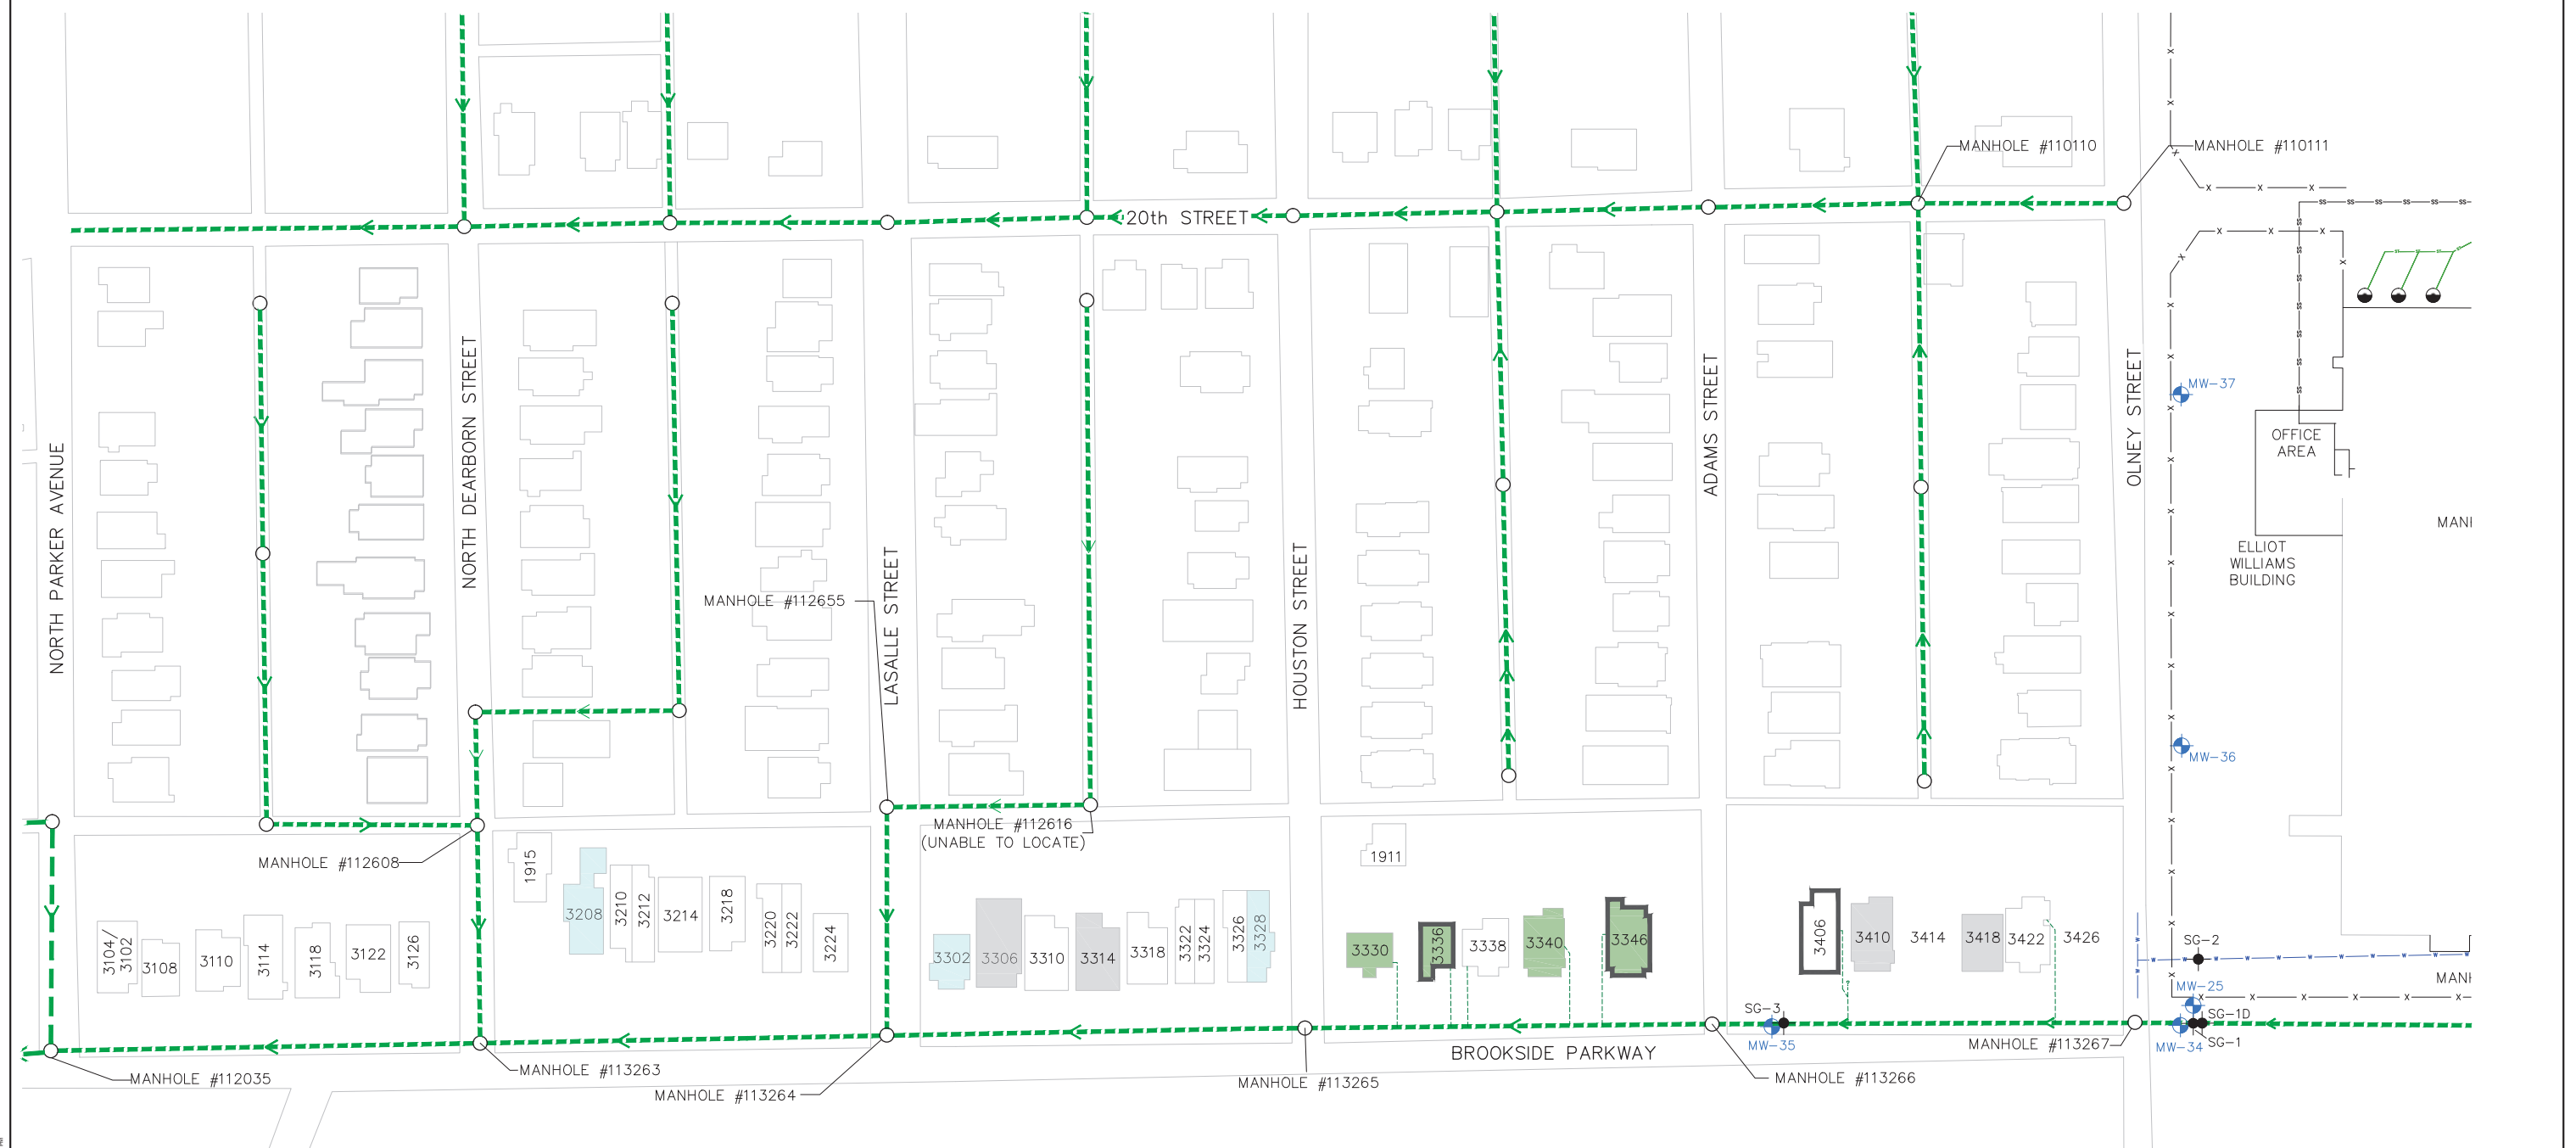
CHEMTURA SITE			
3500 EAST 20TH STREET			
SCALE: AS NOTED	PROJECT NUMBER: 0368504	SHEET: FIGURE 5	REV.
DATE: 11/24/16

MITIGATION STATUS OF HOMES ON BROOKSIDE PARKWAY

- ACCESS DECLINED
- HOME HAS VAPOR MITIGATION SYSTEM (SUBMEMBRANE AND/OR SUBSLAB DEPRESSURIZATION SYSTEM)
- HOME HAS RECEIVED AN AIR PURIFICATION UNIT
- HOME HAS RECEIVED PLUMBING CORRECTIONS

The mitigation options discussed in this section constitute interim actions which were planned in parallel with implementation of the proposed long term remedy (sewer abandonment and rerouting) to address the VI migration pathway. A discussion of mitigated homes and the associated mitigation approach is found in the following sections. The mitigation status of homes along Brookside Parkway is shown on **Figure 5**.
